Anzeigeempfindlichkeit überwachen und kontrollieren

FLUXA®-Testkörper 9803.001

Monitoring and checking the indicating sensitivity

FLUXA® Test Block 9803.001

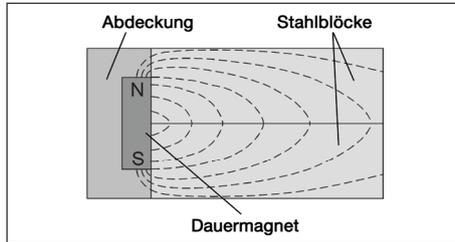
Funktionsweise

Der FLUXA®-Testkörper besteht aus zwei präzise aufeinander eingeschliffenen Stahlblöcken, die mit ihren Berührungsflächen einen künstlichen Riss bilden. An einer Stirnfläche befindet sich unter einer Messingabdeckung ein Dauermagnet. Dieser verursacht über dem künstlichen Riss einen magnetischen Streufluss, der mit wachsender Entfernung vom Magneten schwächer wird. Eine nachlassende Anzeigeempfindlichkeit eines Prüfmittels macht sich daher als nachlassende Risslänge bemerkbar.

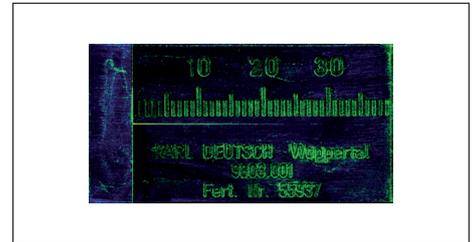
Rissanzeige unter UV-Licht

Den FLUXA®-Testkörper für einige Sekunden in das Rissprüfmittel tauchen oder vorsichtig bespülen. Überflüssiges Prüfmittel zunächst abtropfen lassen. Danach den Riss unter UV-Licht (Betrachtungsbedingungen gemäß EN ISO 3059 beachten!) betrachten. Seine Länge auf der eingravierten Skala in mm ablesen und protokollieren.

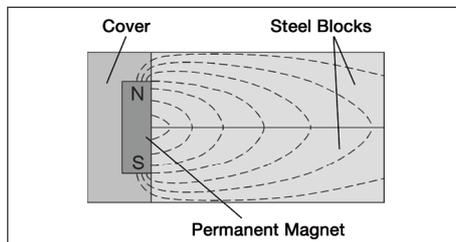
Functioning

The FLUXA® Test Block consists of two precisely ground steel blocks which form an artificial crack at their contact areas. On one front side, a permanent magnet is arranged under a brass cover. This magnet causes a magnetic stray flux across the artificial crack, which decreases more and more with increasing distance from the magnet. Thus, a deterioration of indication sensitivity can be determined by a reduction of the indication length.

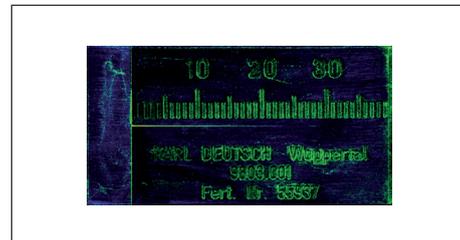
Crack Indication under UV Light

Immerse the FLUXA® Test Block for a few seconds in, or carefully spray it with the well-mixed inspection medium. Let redundant inspection medium drop off. After this, inspect the artificial crack under UV light (inspection conditions according to EN ISO 3059 should be ensured) and read its length from the engraved mm scale and record it.
